## UNITED STATES ENVIRONMENTAL PROTECTION AGENCY

**Region 9 Enforcement and Compliance Assurance Division**  
**75 Hawthorne Street**  
**San Francisco, CA 94105**  
**RCRA INSPECTION REPORT**

<b>Inspection Date(s):</b>	6/23/2021	<b>Inspection Announced:</b> Yes
<b>Time:</b>	<b>Entry:</b> 9:00 am	
<b>Regulatory Program(s)</b>	RCRA Subtitle C (Hazardous Waste)	
<b>Company Name:</b>	Evoqua Water Technologies	
<b>Facility/Site Physical Location:</b>	2523 Mutahar Street	
<b>(city, state, zip code)</b>	Parker, AZ 85344	
<b>Geographic Coordinates:</b>	34.13249, -114.27262	
<b>County</b>	La Paz	
<b>Facility/Site Contact:</b>	Russell Smith	Plant Manager
	Russell.smith@evoqua.com	(928) 669-5758 ext. 17
<b>Facility/Site Identifier:</b>	AZD982441263	
<b>Generator Status</b>	Permitted Treatment, Storage & Disposal Facility (TSDF) Large Quantity Generator (LQG)	
<b>NAICS:</b>	562211 – Hazardous Waste Treatment & Disposal	
<b>Facility/Site Personnel Participating in Inspection:</b>		
Russell Smith	Evoqua Water Technologies	Plant Manager
Don Breaux	Evoqua Water Technologies	Senior Supervisor of Production
Matthew Myers	Evoqua Water Technologies	Corporate Environmental Manager

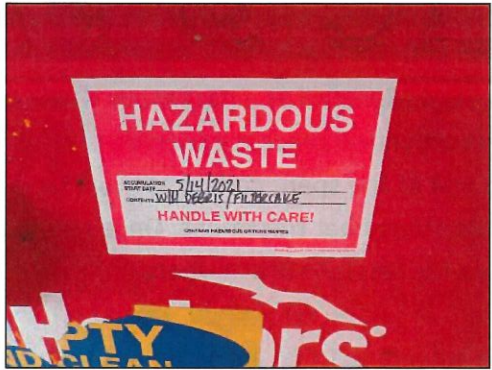
NO	OBSERVATION	PHOTOGRAPH	Regulatory Area of Concern
1	The inspectors observed that a label on the roll-off bin of debris with filter cake (D018, F001, F002, F003, F004, F005) was not marked with an indication of the hazards of the contents.

<p>Photo P6230008.JPG</p>	A LQG must mark or label its containers with an indication of the hazards of the contents (examples include, but are not limited to, the applicable hazardous waste characteristic(s) (i.e., ignitable, corrosive, reactive, toxic); hazard communication consistent with the Department of Transportation requirements at 49 CFR part 172 subpart E (labeling) or subpart F (placarding); a hazard statement or pictogram consistent with the Occupational Safety and Health Administration Hazard Communication Standard at 29 CFR 1910.1200; or a chemical hazard label consistent with the National Fire Protection Association code 704) [40 CFR 262.17(a)(5)(B)]

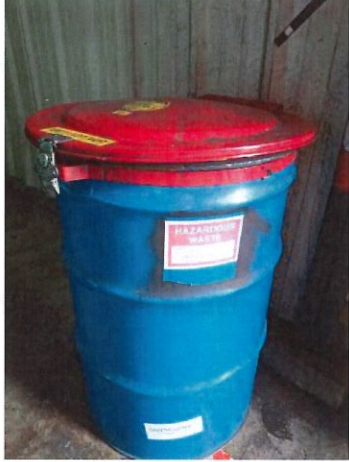
NO	OBSERVATION	PHOTOGRAPH	Regulatory Area of Concern
2	The inspectors observed that a satellite accumulation container (SAA) of hazardous warehouse debris was not marked with an indication of the hazards of the contents.

<p data-bbox="607 821 846 848">Photo P6230012.JPG</p>	A LQG must mark or label its containers with an indication of the hazards of the contents (examples include, but are not limited to, the applicable hazardous waste characteristic(s) (i.e., ignitable, corrosive, reactive, toxic); hazard communication consistent with the Department of Transportation requirements at 49 CFR part 172 subpart E (labeling) or subpart F (placarding); a hazard statement or pictogram consistent with the Occupational Safety and Health Administration Hazard Communication Standard at 29 CFR 1910.1200; or a chemical hazard label consistent with the National Fire Protection Association code 704) [40 CFR 262.17(a)(5)(B)]
